# COST, PERFORMANCE, AND ESTHETIC IMPACTS OF AN EXPERIMENTAL FOREST ROAD IN MONTANA

USDA Forest Service Research Paper INT-203

USDA Forest Service  
Research Paper INT-203  
April 1978

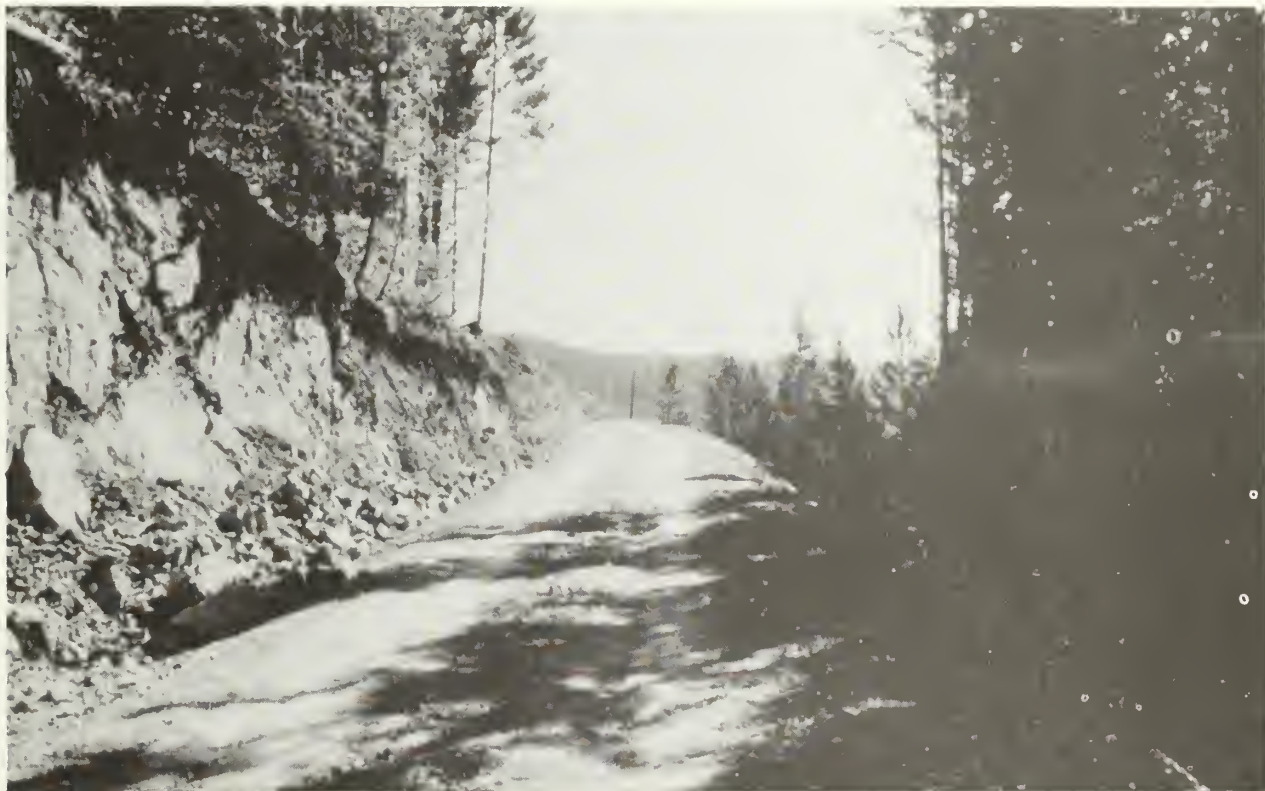
*Figure 2.--Near station 54+00--view of 1/10:1 backslopes before final grading.*

*1/10:1 backslopes.*--Two photos taken from approximately station 54+00, after the first winter and after final grading, tell the story. Figure 2 shows two or three sections where 1/2 to 1 cubic yard ( $0.13\text{-}0.26\text{ m}^3$ ) of rock sloughed off the cut bank. Figure 3 shows the same section of road after final grading and how it appeared the balance of the year. Only minor sloughing is likely in the future.

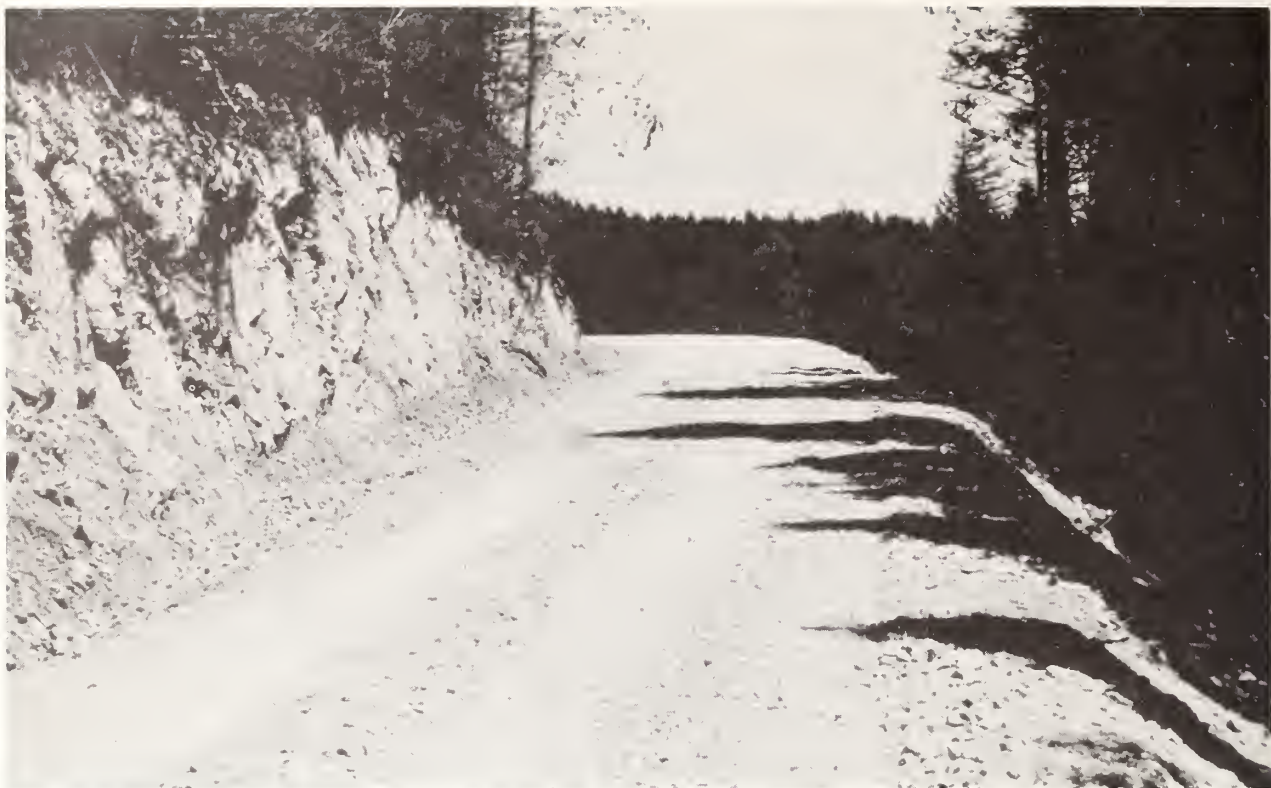
*Figure 3.--Near station 54+00--view 1/10:1 backslopes after final grading.*

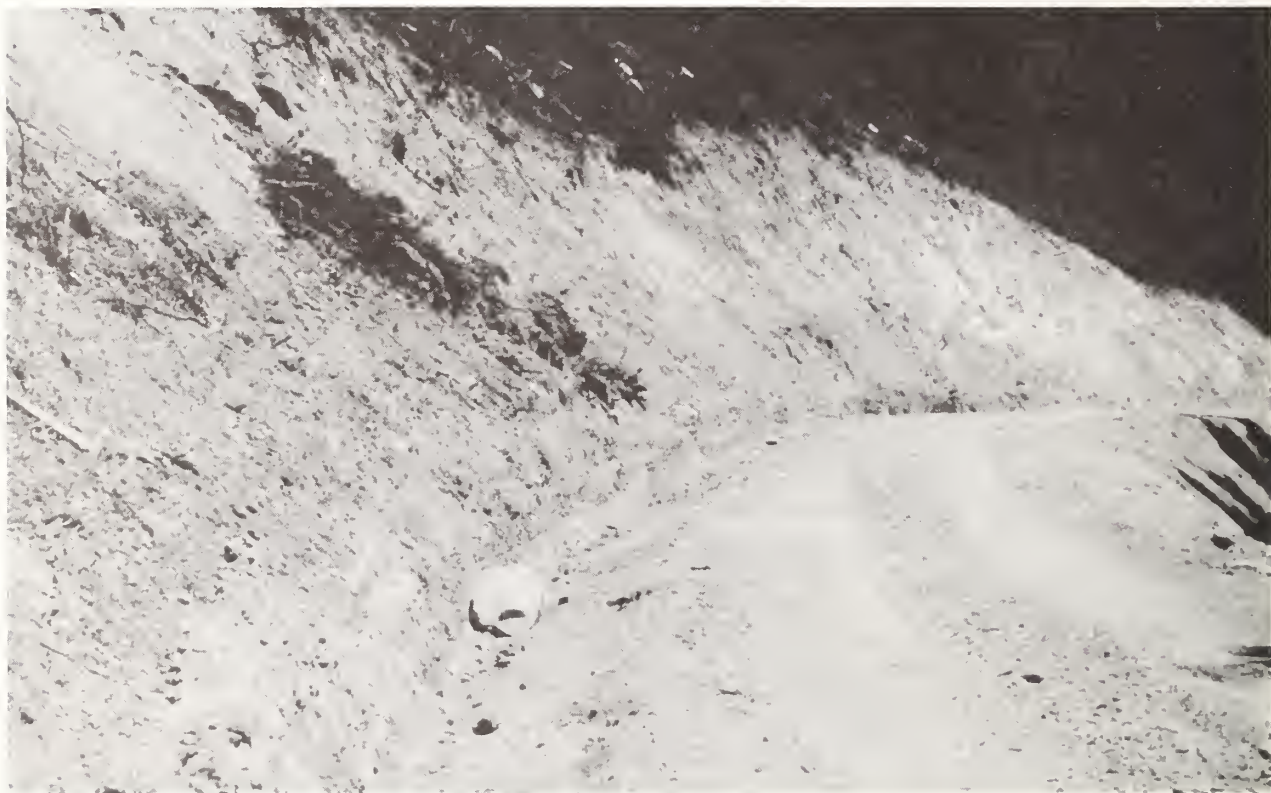
*Figure 4.--Slumping cut slope near station 37+20.*

*3/4:1 backslopes.*--Two areas of 3/4:1 backslopes showed some sloughing or slumping after the first winter, but are now relatively stable and no major failures are anticipated. Figure 4 shows minor slumping at station 37+20 on a relatively long slope in the deepest soil mantle found on the entire road. Some minor sloughing or slumping could be expected on 3/4:1 backslopes in this material.

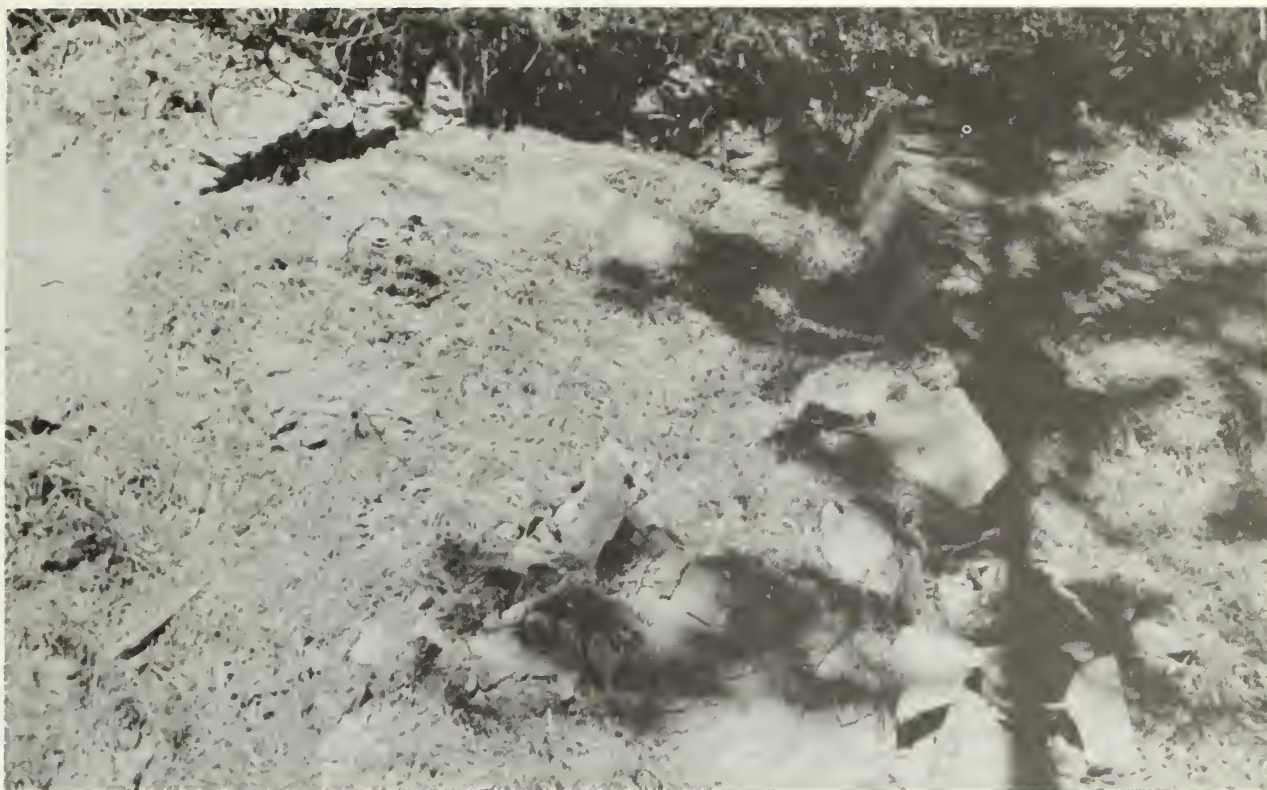
*Figure 5.--Minor settlement in rock fracture at station 64+34.*

A minor U-shaped settlement occurred in the cut bank at station 64+34 (fig. 5) because of rock fracturing.

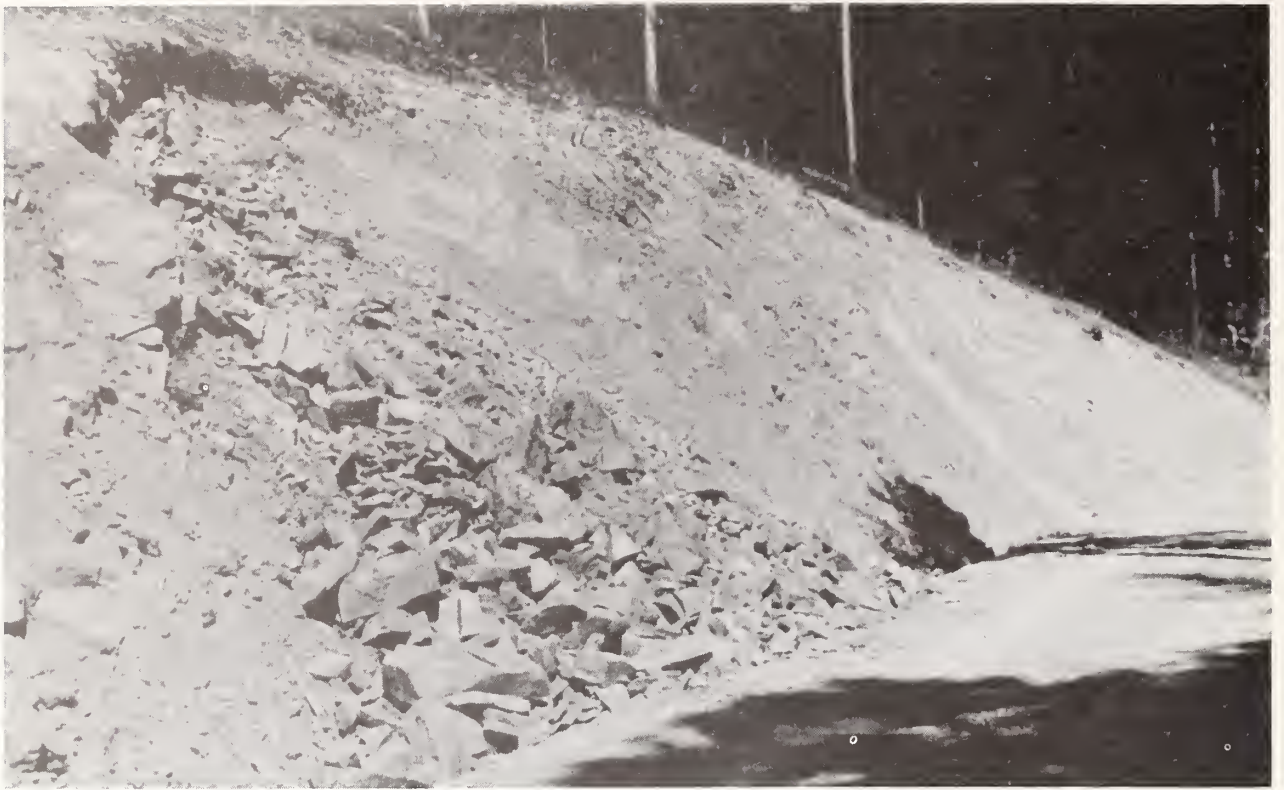
*Figure 6.--Rock slab spalling due to dip and fracture at station 76+20.*

In figure 6, several yards of rock slabbed off the cut bank at station 76+20 because of dip and fracture in the bedrock. No further sloughing of any extent is expected here.

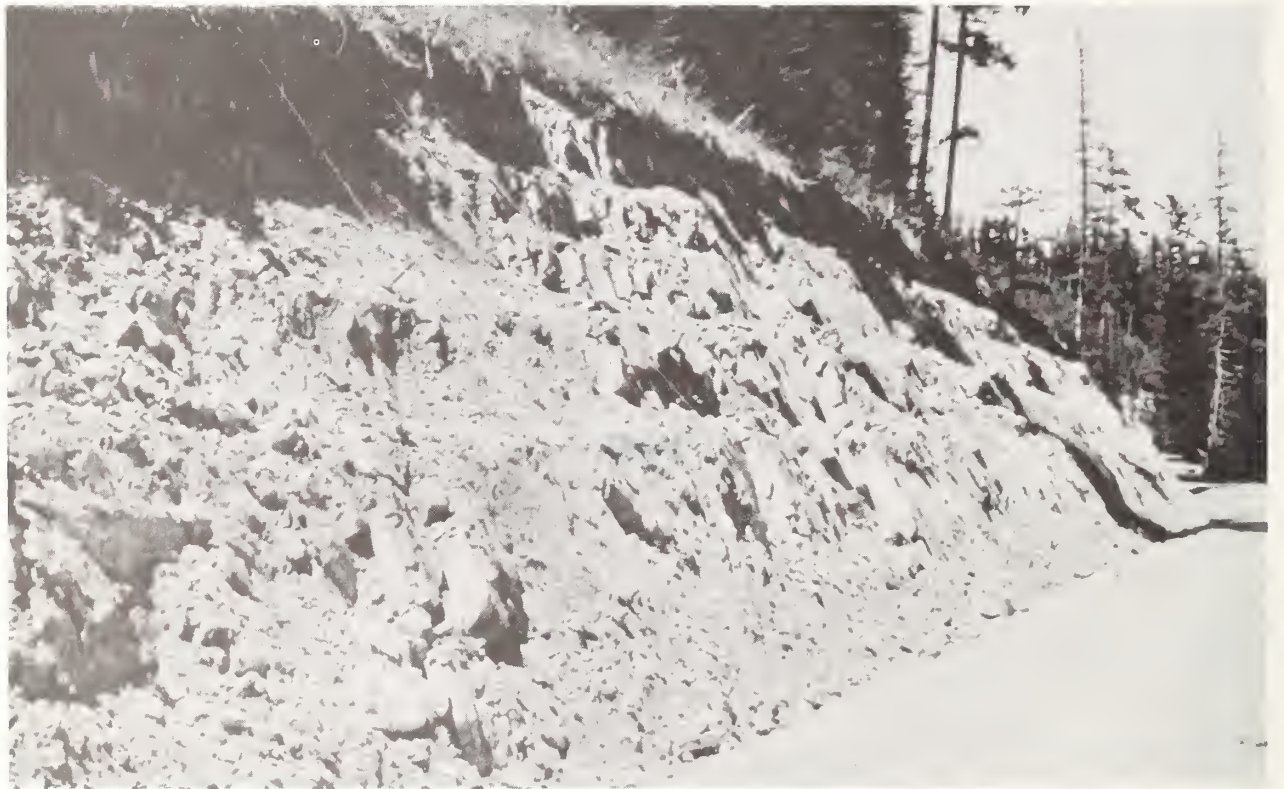
*Figure 7.--Stepped backslopes in rock cut near station 82+50.*

*Stepped or serrated backslopes.*--An experimental section of approximately 450 feet (137 m) of backslope was stepped to test growth of grass and shrubs and to evaluate esthetics and stability. This area has relatively high precipitation and a favorable aspect. Revegetation success was generally good. Figure 7 shows a completed section of serrated backslope. The dip and strike of the rock formations made stepping difficult and resulted in the steps being not quite as wide as planned. The steps have been planted, and it is believed that most of the sloughing expected has taken place. Sloughing eventually leaves less pronounced steps, but provides a seedbed and more moisture to the plants.

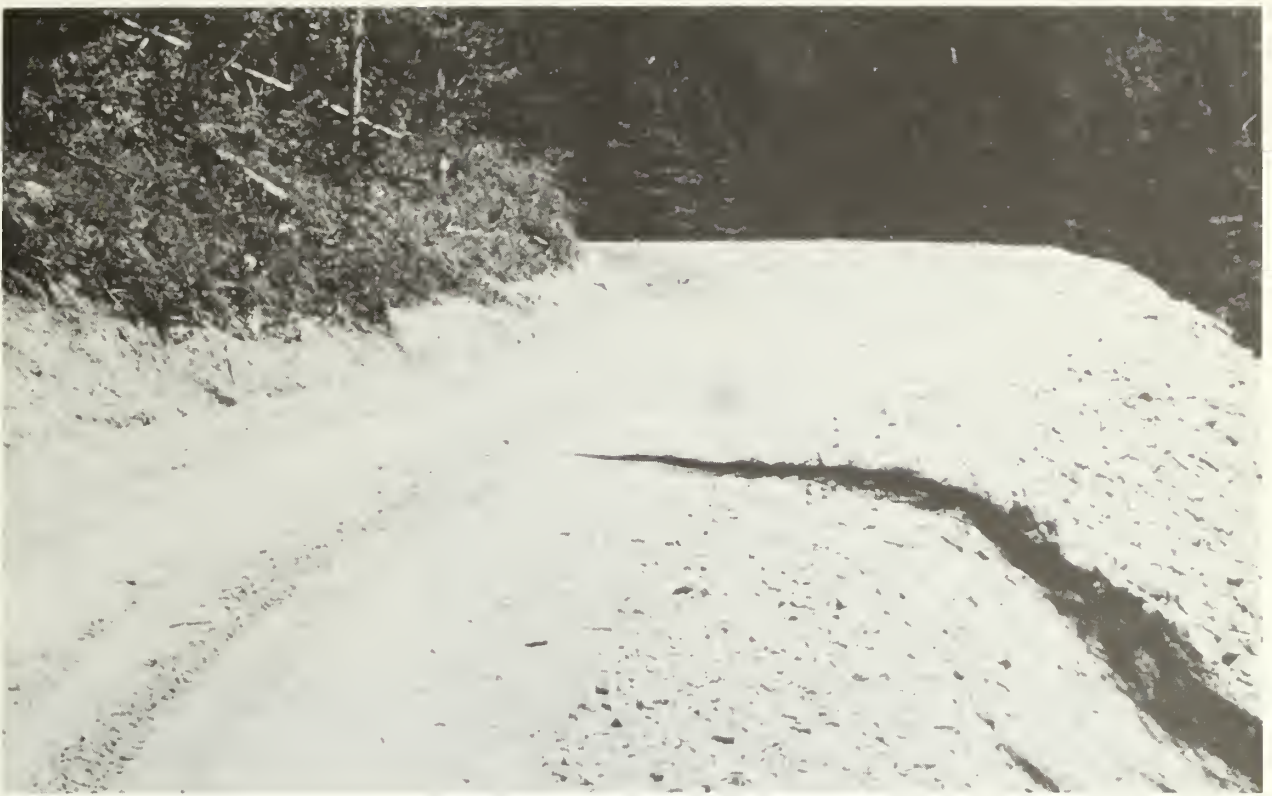
*Figure 8.--Typical side-cast fill on 1 1/2:1 slope at station 87+75.*

*Fill slopes.*--Fills were designed on either a 1 1/2:1 or 1 1/4:1 slope, depending on the material. Many sections contained enough rock to support 1 1/4:1 slopes. Fill slopes were compacted by the earth moving equipment. Figure 8 shows a typical fill at station 87+75. The material in the area of station 93+00 produced the only section where the fill slope was slightly undulating, shown in figure 9.

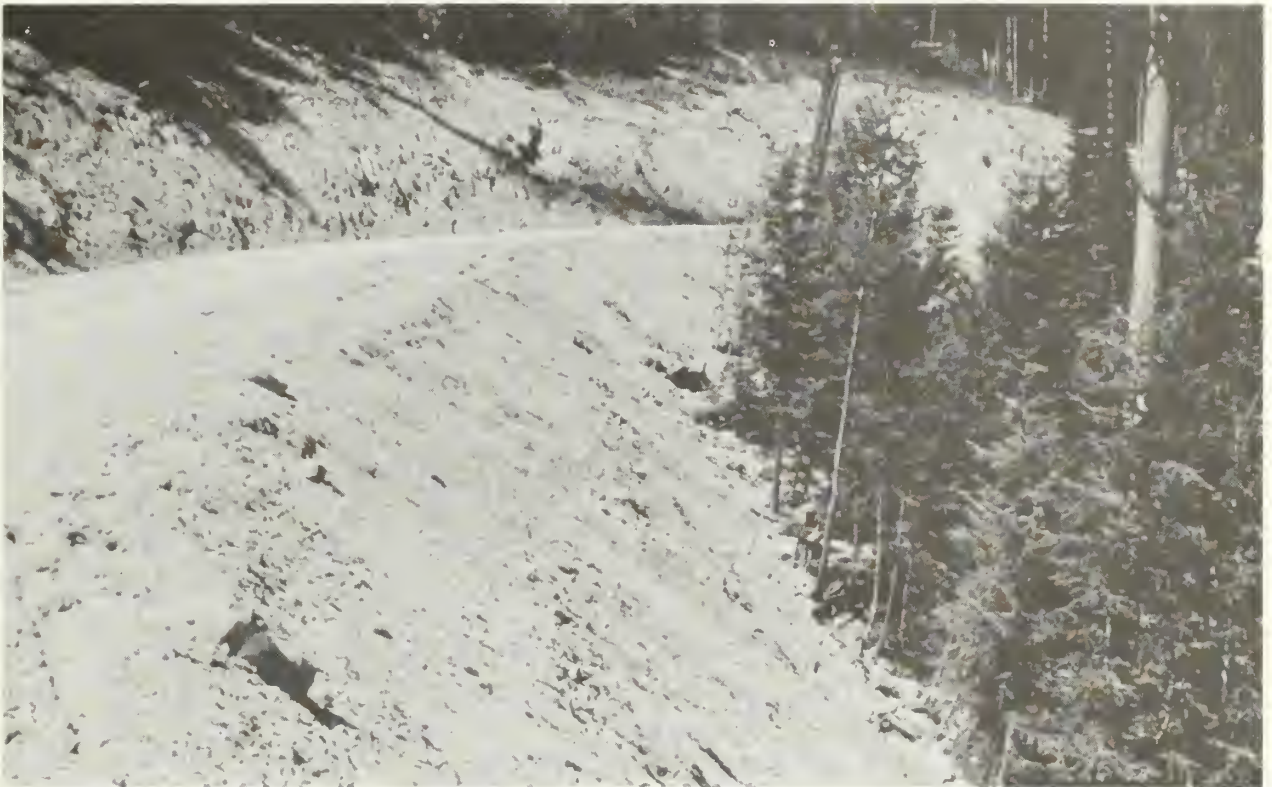
*Figure 9.--Fill containing some fine colloidal material that produced a slightly uneven but stable slope at station 93+00.*

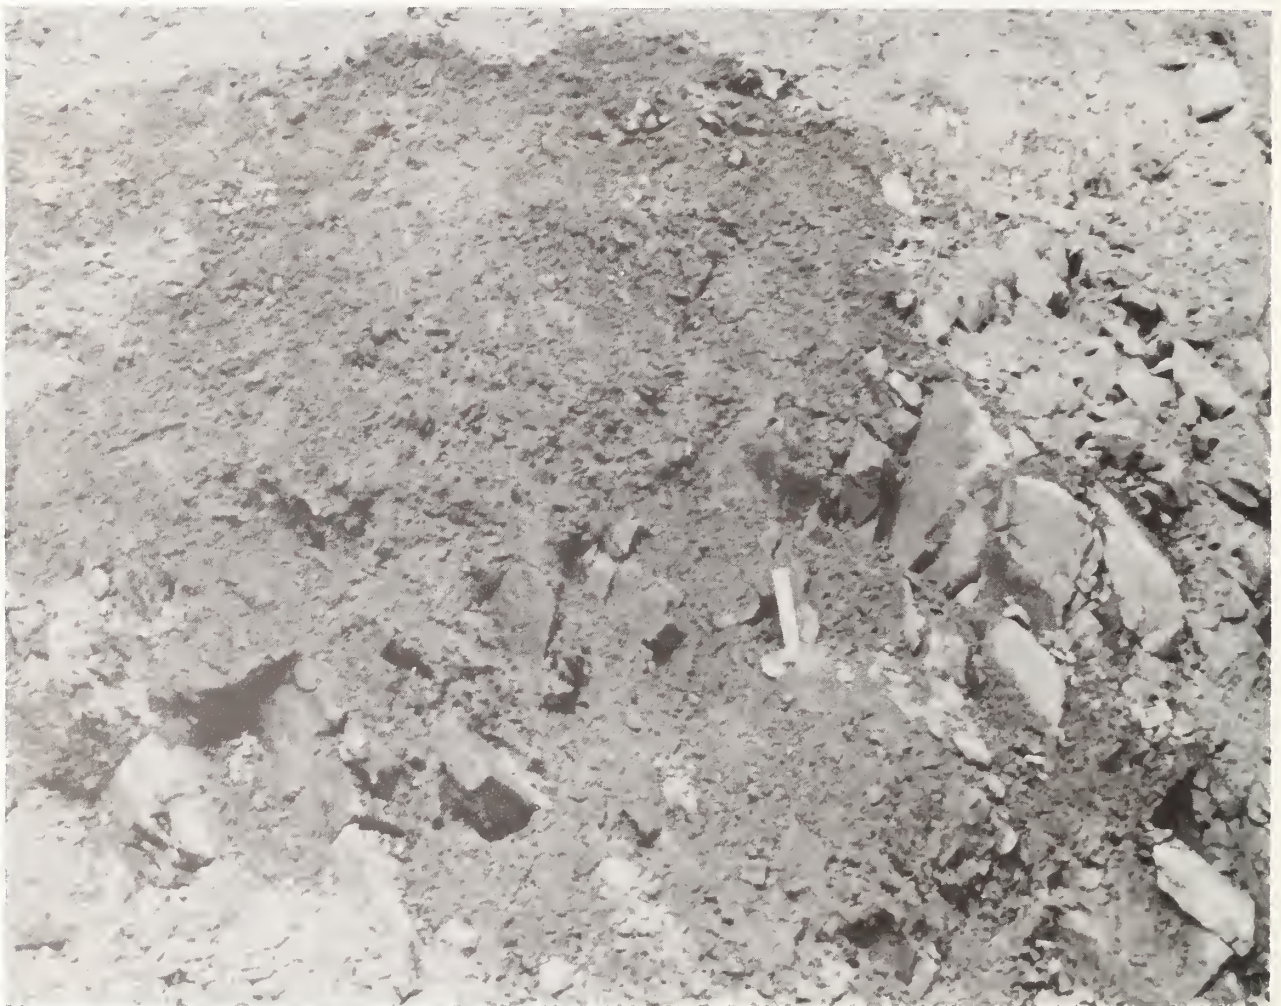
*Figure 10.--Typical minor seepage at station 41+00.*

Minor seepage was recorded in April from four cut bank sections at stations 12+40, 21+75, 41+00, and 55+00. The seepage at the first two locations continued throughout the year, but no damage resulted from the seepage. A typical area of seepage is station 41+00, shown in figure 10.

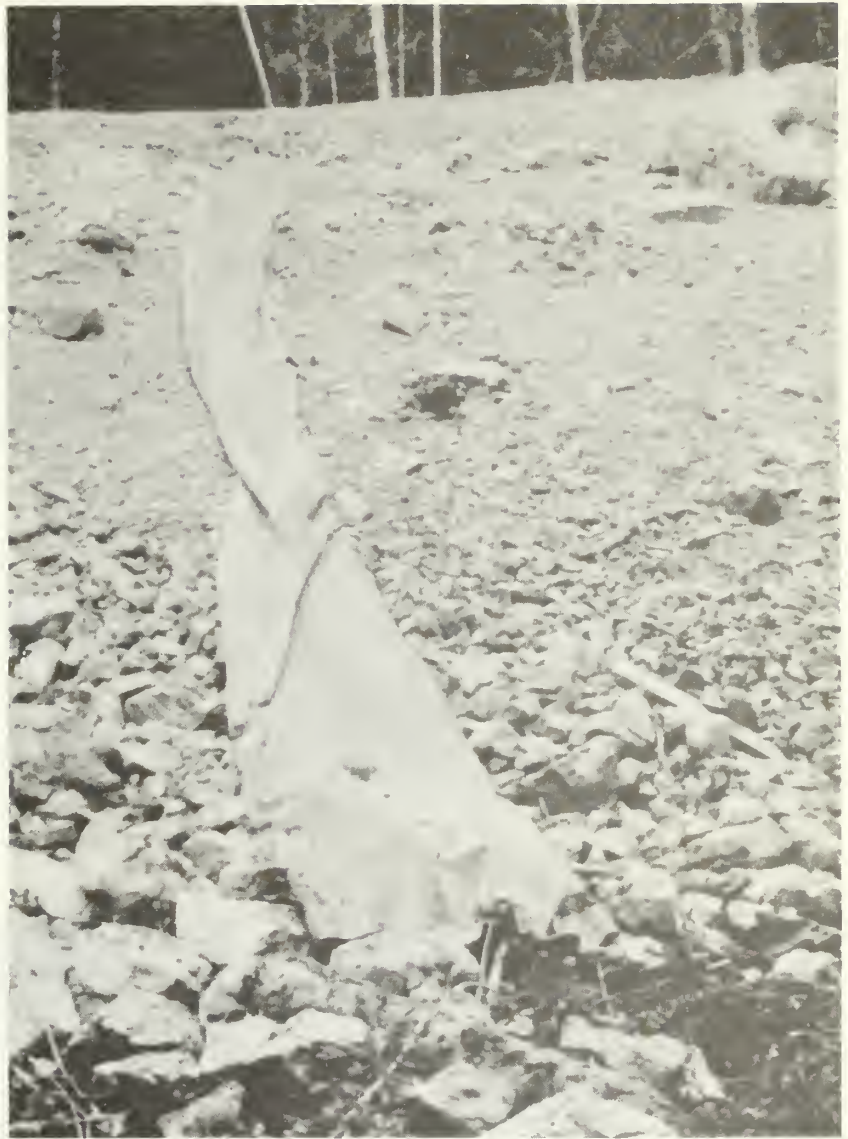
*Figure 11.--Neoprene down-spout laid on top of fill at station 57+50.*

Neoprene downspouts were used because of their greater stability on fill slopes and effectiveness in dissipating part of the energy under conditions of flow. The installation at station 57+50 is shown in figure 11.

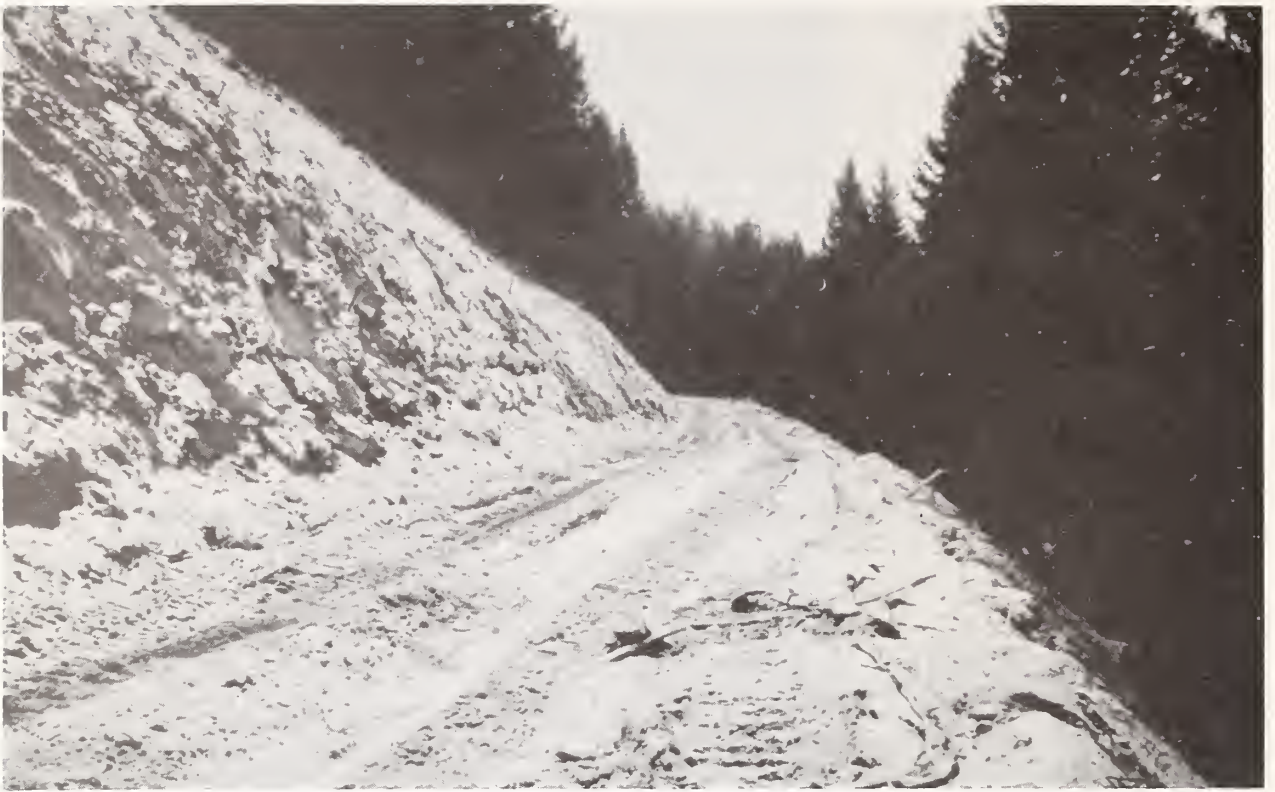
*Figure 12.--Road section, conventional clearing.*

The difference in overall appearance between the standard and reduced clearing widths can be seen in figures 12 and 13. As previously discussed, reduced clearing widths generally reduce esthetic impacts.

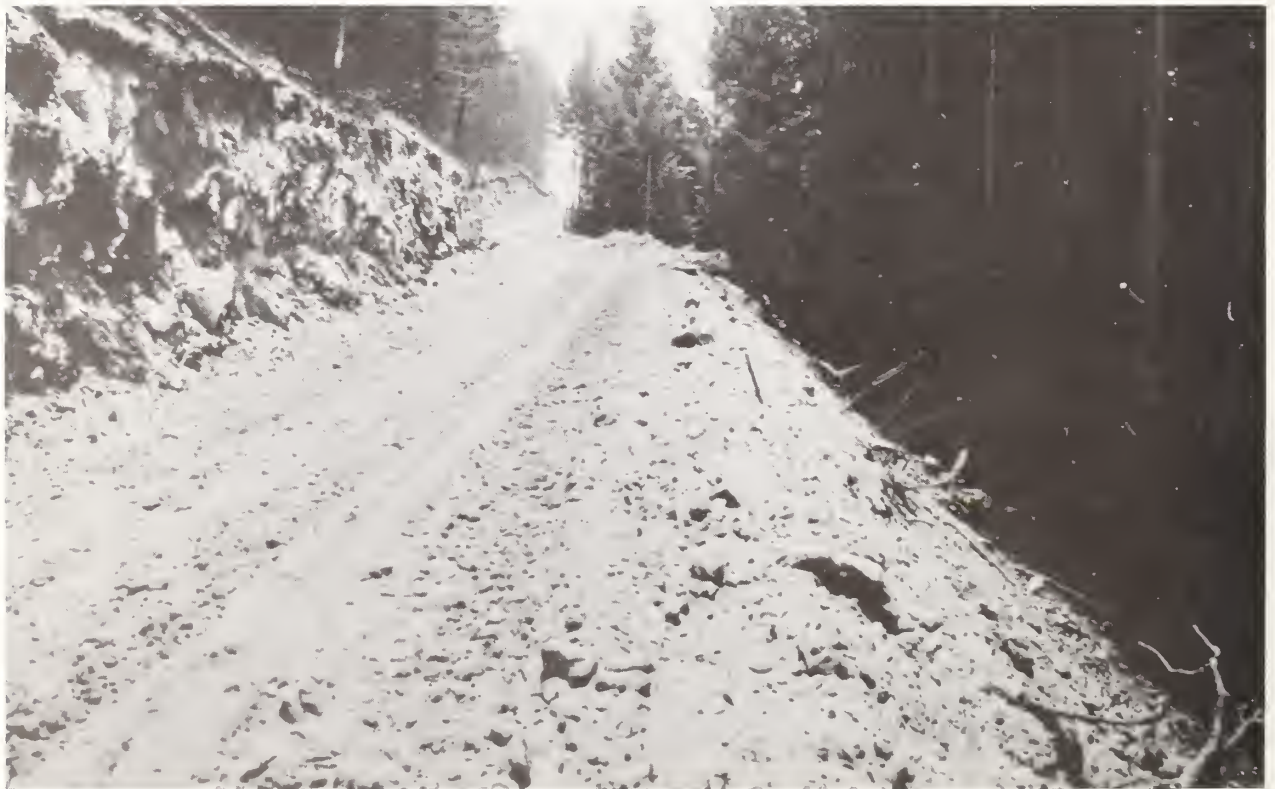
*Figure 13.--Road section with vertical cut and reduced clearing width.*

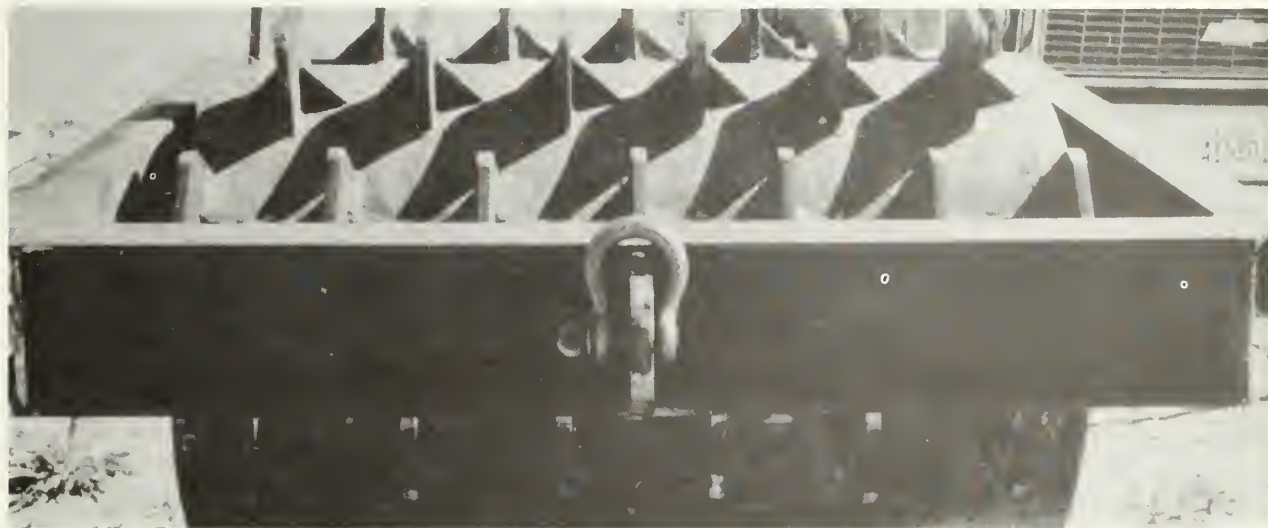
*Figure 14.--Angeles N.F. roller-compactor.*

Fill slopes that are difficult to revegetate have generally been most successfully treated by applying a mulch held in place by netting or impregnation. The sheep's foot-type roller, designed by the Angeles National Forest (fig. 14), has been proven effective in compacting the top 6 to 8 inches (15-20 cm) of soil, while at the same time impregnating straw mulch well into the soil. The roller was used on several fill sections; results will be reported when data have been analyzed. (The experimental seeding and planting were done by research personnel and were not a part of the road contract.)

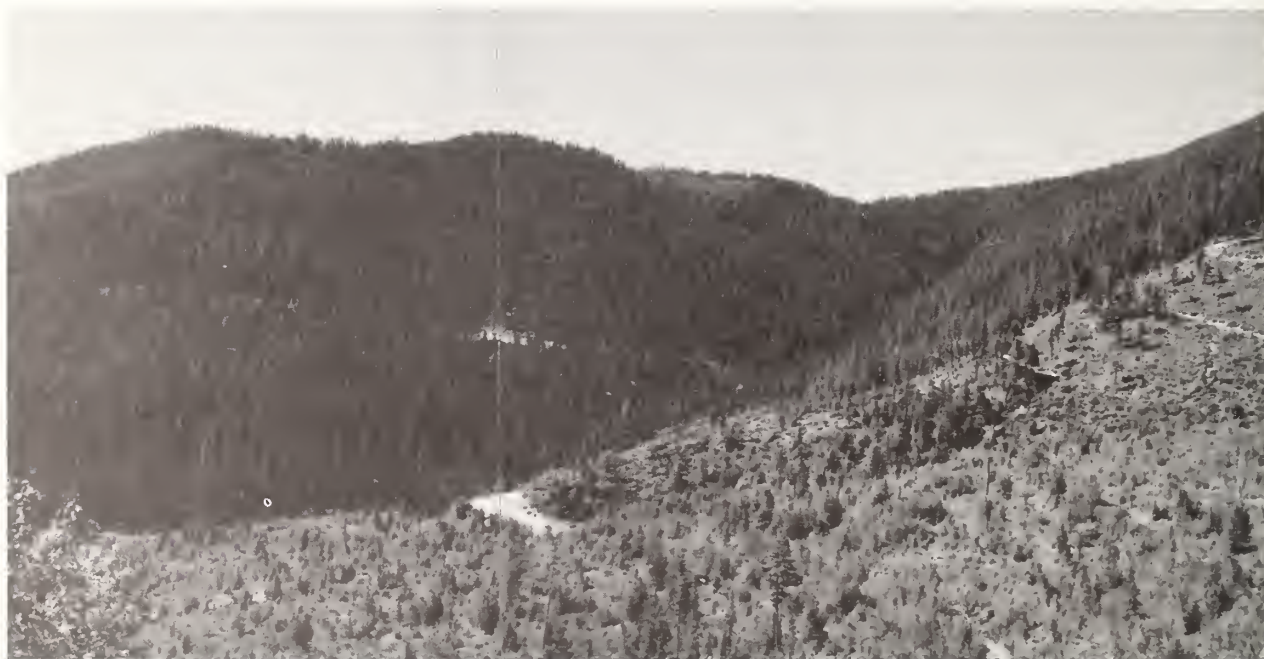
*Figure 15.--Abbot Basin before construction of logging study road.*

In figure 15, the clearing and cross section of the old road are prominent in the center of the picture. In figure 16, the same view after the new road was completed, the clearing for the new road is barely visible above the old road. Figure 12 shows a cut-and-fill section using conventional backslopes and clearing specifications. Compare this photo with figure 13 where 1/10:1 backslopes and reduced clearing widths were used. (Both photos were taken before final cleanup and grading.)

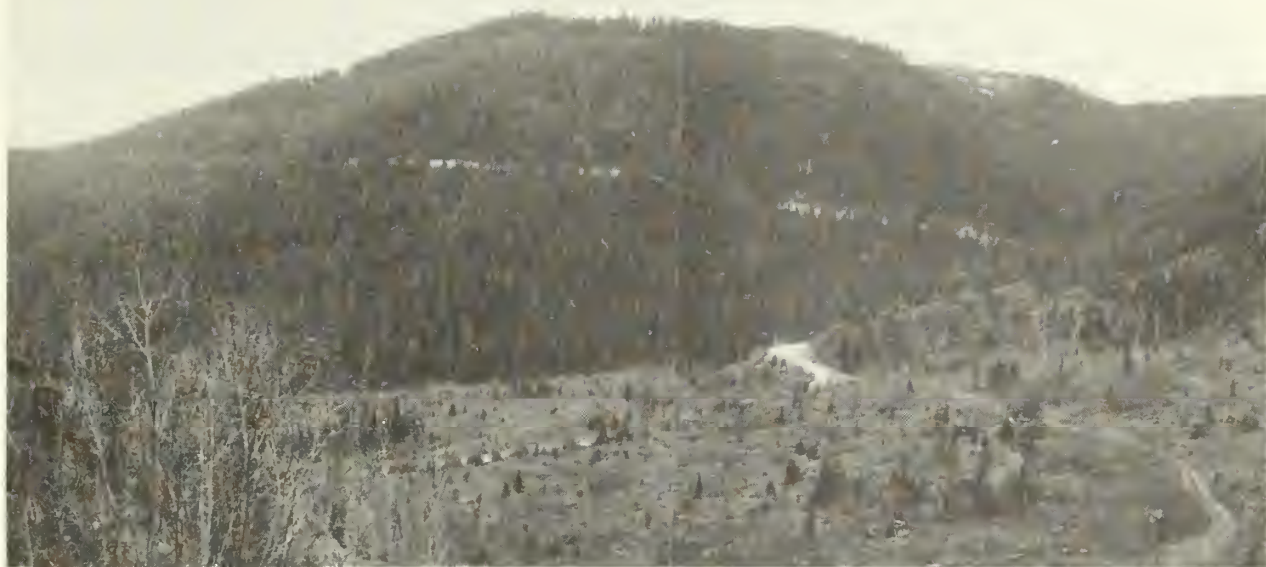
*Figure 16.--Abbot Basin after construction of logging study road.*
